## SGT Feature Analysis

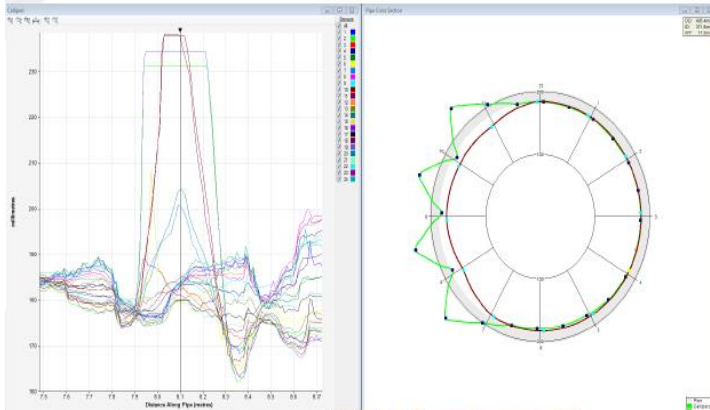
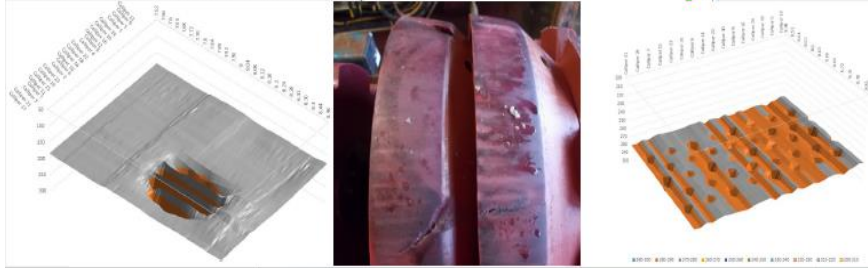
These charts represent the SGT negotiating a barred and sphere Tee.

Often Tee piece and bars can be the suspect of pig damage.

A routine SGT will often provide the information necessary to sustain or refute the accusation.
